Sierra Home Inspection

CONFIDENTIAL INSPECTION REPORT

1234 New St, Placerville, CA 95667

2/14/2014 9:00 am to 12:00 pm

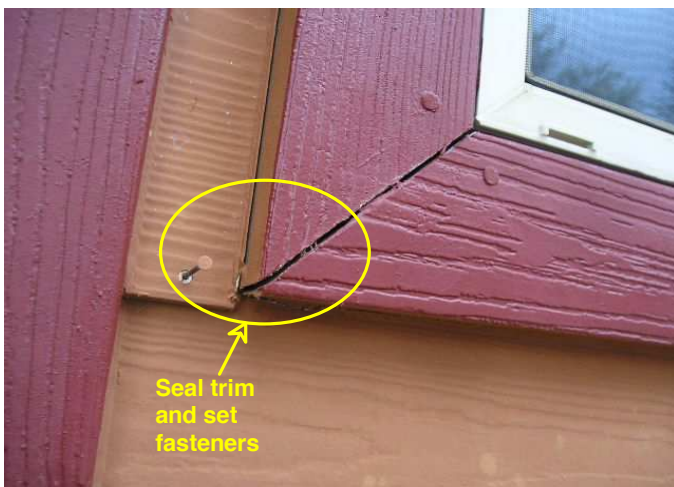
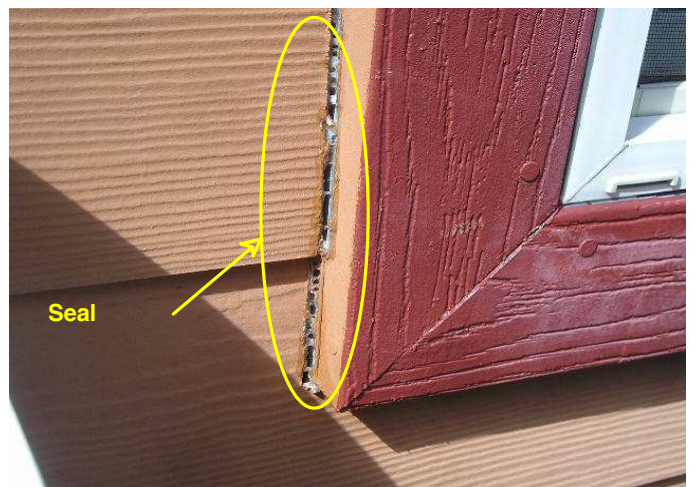
- Sections of the fascia and trim need maintenance type service, and particularly on the south facing side where they are exposed to direct sunlight. Maintenance items include but are not limited to sealing seams around doors and windows, resetting fasteners, and painting.

2.1 - □ The fascia and trim need typical maintenance-type service

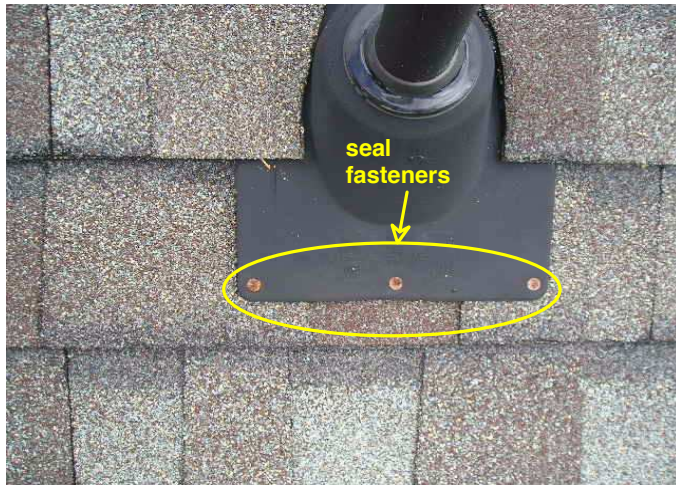
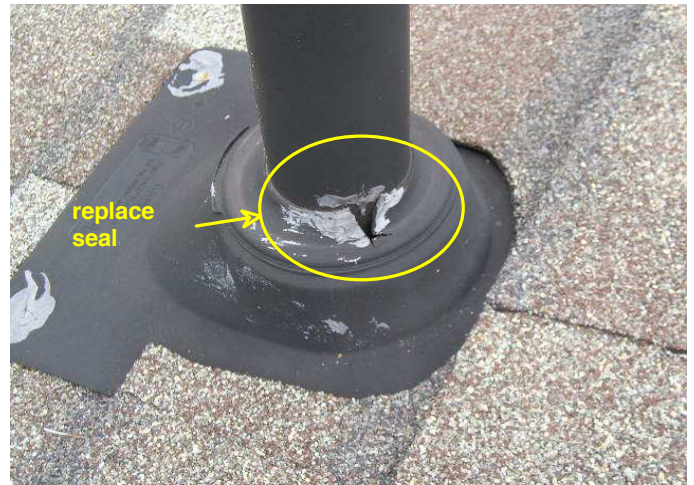
- ☐ The fasteners holding down the roofing material are recommended to be sealed where exposed to prevent water intrusion.

3.1 - Seal fasteners in the roofing material

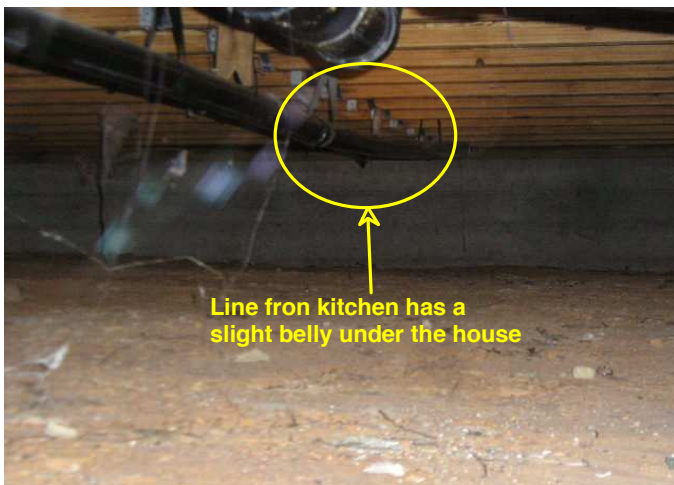
- A drainpipe under the house has negative grade and is recommended to be corrected.

4.3 - A drainpipe under the house has negative grade and is recommended to be corrected
